INSPECTION + MONITORING = PROCESS OPTIMIZATION

The Challenge

A petrochemical plant in the Gulf Coast, USA, previously employed a manual inspection program on a 12' x 80' tank more than 15 years old. These manual UT thickness inspections utilized a grid strategy in what they deemed "critical" locations across the asset, measured one time per year.

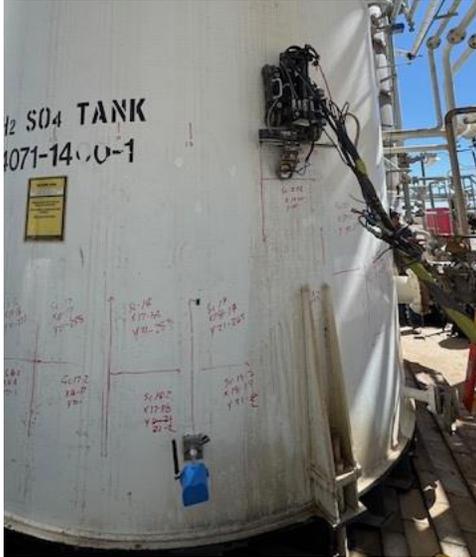
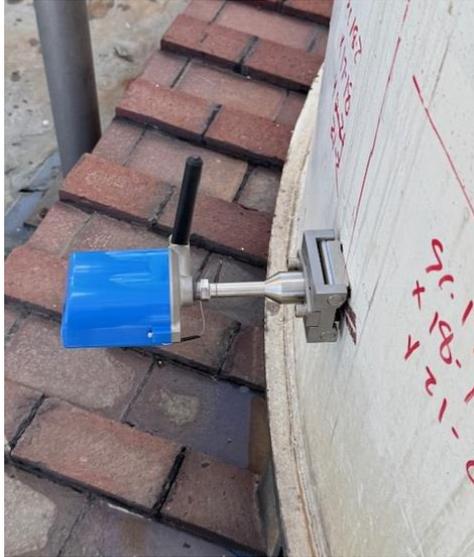
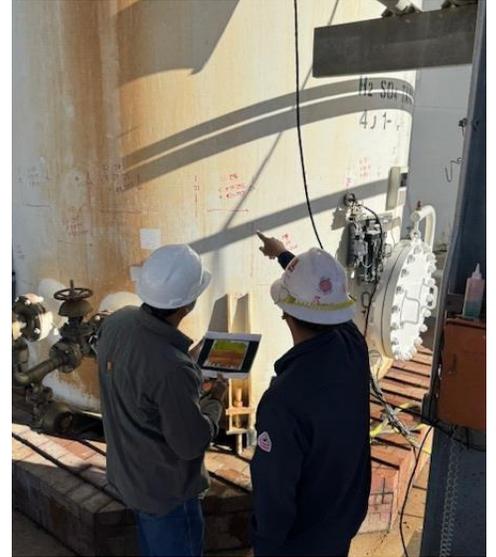
The Asset Integrity Team elected to move from an annual manual inspection strategy to a tri-annual fully automated/robotic, 100% health/UT thickness scan of the tank. In conjunction with this new inspection, the Asset Integrity Team would identify 'critical locations' based on a red/yellow/green heat map (thinnest locations red, thickest locations green) and place fixed sensors in those locations monitoring once per day to produce a corrosion rate to 0.001" accuracy.

Based on the corrosion rates from these sensors, the Asset Integrity Team then overlays thickness data with operational data to discern when, where, and how corrosion activity compares to process operations. The primary objective is to enhance process optimization via corrosion remediation or asset life extension. Secondly, to predict maximum useful asset life and plan maintenance/replacement schedules accordingly.

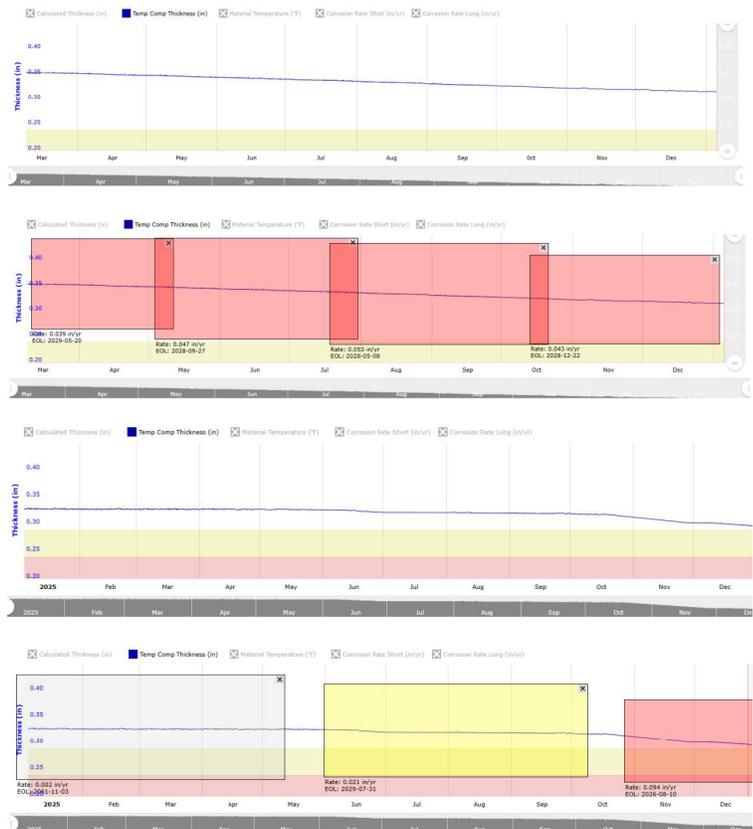
- Time: 2 day w/ 2-person crew (16 man-hours)
- Annual Cost: ~\$17,000 (\$50,000 / 3 years ... tri-annual inspection/monitoring)
 - Robotic Inspection: ~\$25,000
 - Sensors: ~\$25,000 (Sensors are reusable/redeployable, so only a one-time cost)
- 0 incidents reported
- Asset owner is actively working with operations to remediate corrosion/extend the life of the asset (see data on the right)
